Powlett River Estuary Management Plan – Threats to the health of the Estuary

Powlett River Estuary – Threats

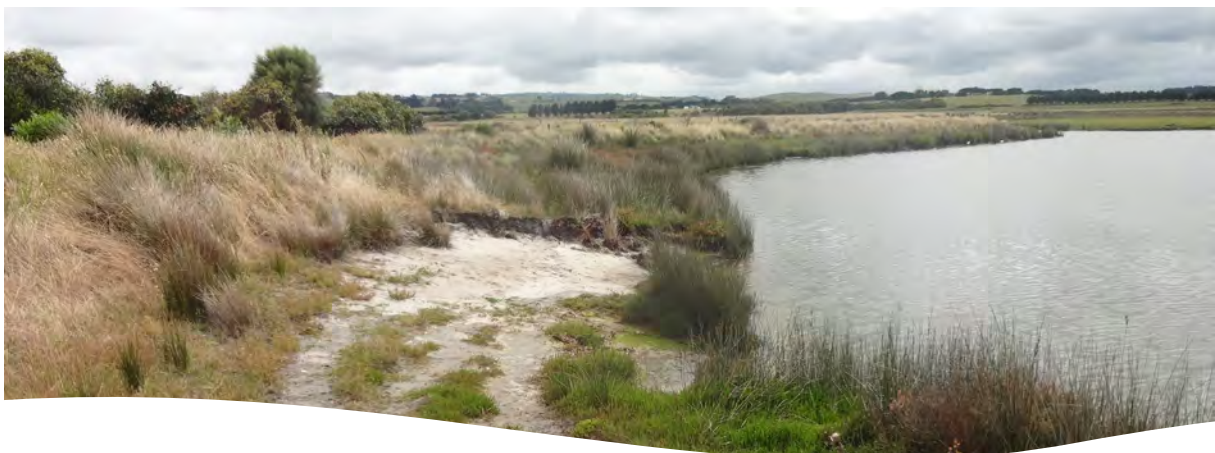
Bare ground associated with pedestrian access.

- Rural drainage and drain clearing
- Litter
- Channelisation of the river channel
- Trampling and bank erosion associated with pedestrian access.

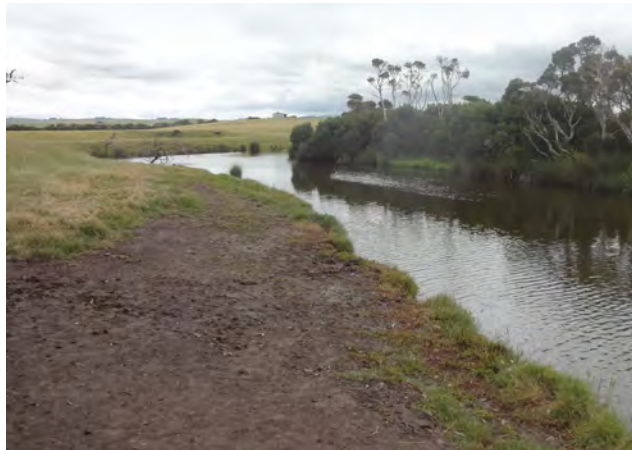
Livestock access leaving bare ground and pugging.

- Degraded water quality
- Bank instability
- Disturbance of acid sulphate soils
- Livestock access
- Altered marine exchange.

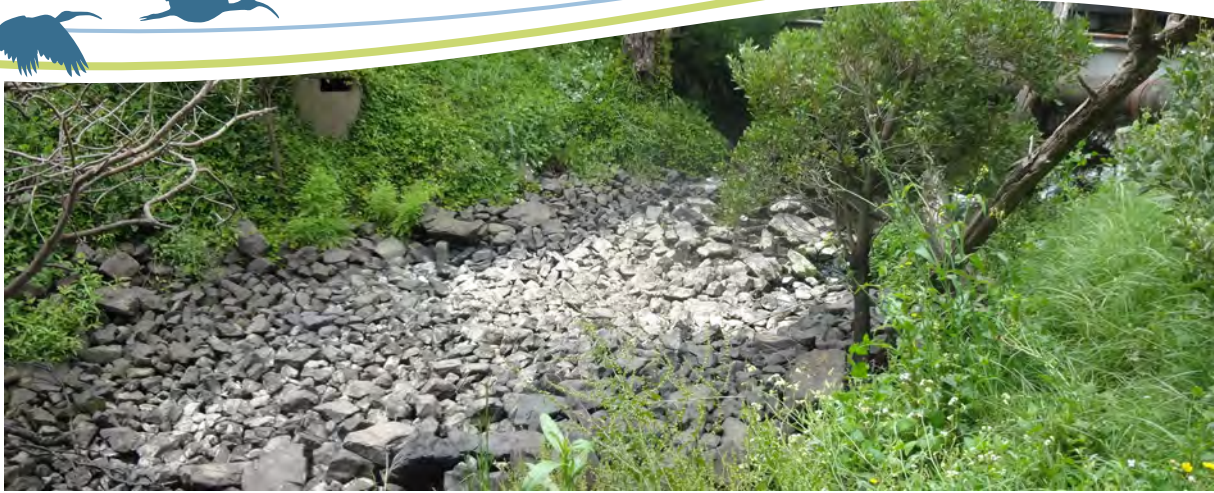
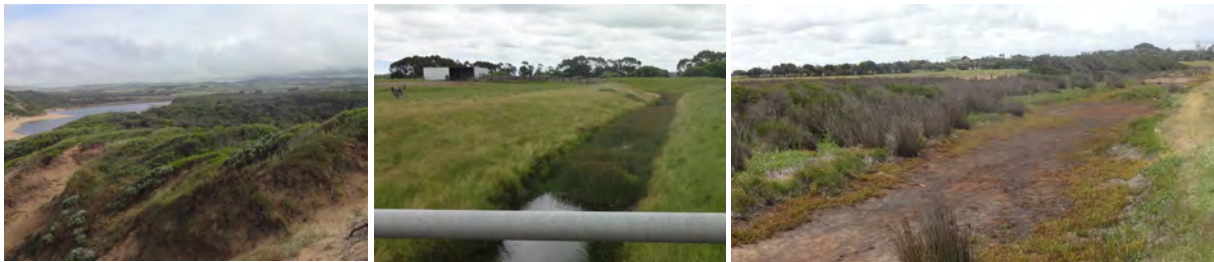
Top: Fish barrier on the Powlett River. Above left: Threats within the catchment impact estuary health and condition. Centre: Rural drainage and stormwater can lead to water quality issues and impact the health of wetlands by changing the water regime. Right: Draining of coastal wetlands and saltmarsh can expose potential acid sulphate soils.

*There are two barriers to fish movement in reach 27-6. The first is the streamflow gauging station at Wattle Bank and the other is the South Gippsland Water pumping station rock structure at Wonthaggi North.

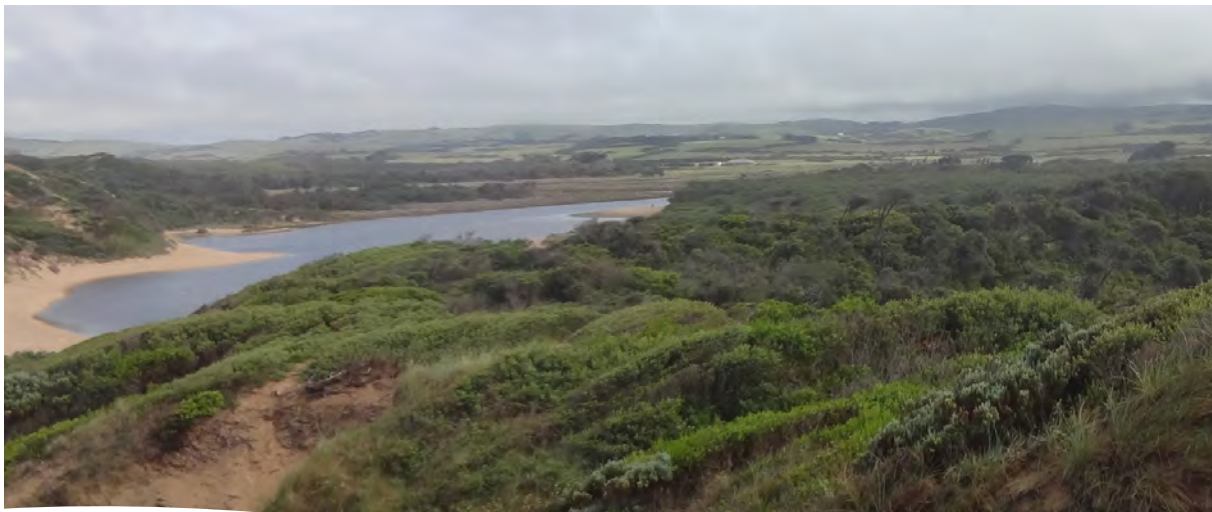
The waterways in the catchment have been channelised and riparian vegetation is lacking, barriers to fish movement exist and the steep hillslopes high in the catchment have been cleared.
